# EXHIBIT O

# Degradation of polypropylene *in vivo*: A microscopic analysis of meshes explanted from patients

Vladimir V. Iakovlev,<sup>1</sup> Scott A. Guelcher,<sup>2</sup> Robert Bendavid<sup>3</sup>

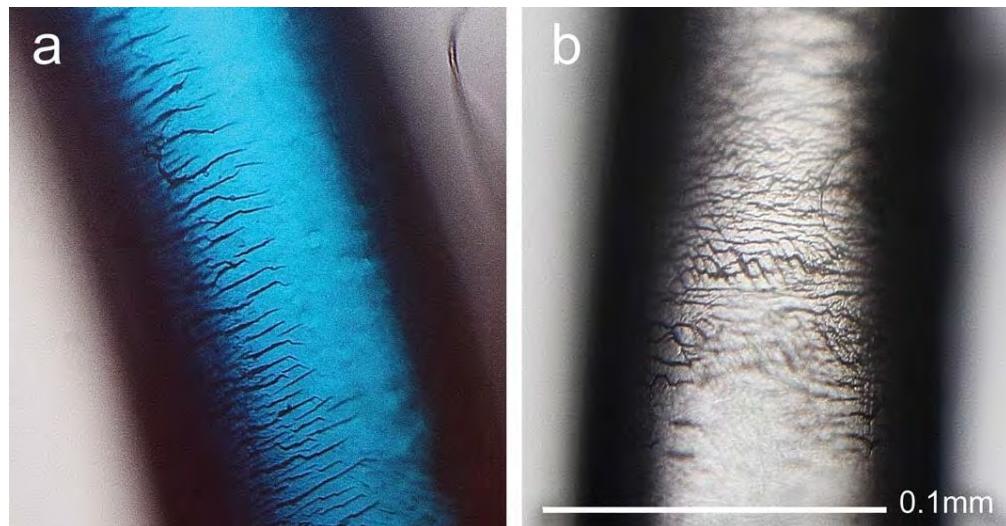
**FIGURE 1.** Surface of the mesh fibers immediately after explantation from the body, transvaginal sling explanted due to pain 9 years after implantation, light microscope,  $\times 20$  objective with image crop. Mesh fibers at the specimen edges had no covering tissue and could be examined as they were in the body, avoiding possible artifacts of tissue removal, drying or contact with formalin. Both blue (a) and clear (b) fibers showed surface cracking. [Color figure can be viewed in the online issue, which is available at [wileyonlinelibrary.com](http://wileyonlinelibrary.com).]

In one case the mesh fibers could be assessed immediately after explantation, before tissue drying or fixation in formalin. The transvaginal sling was excised because of chronic pain 9 years after implantation. Mesh fibers at the specimen edges were free of tissue and could be examined in a conventional microscope after a rinse in saline and without additional preparation (Figure 1). There were transverse cracks at the bending points [Figure 1(a)] and patches of haphazard cracks on straighter portions of the fibers [Figure 1(b)].

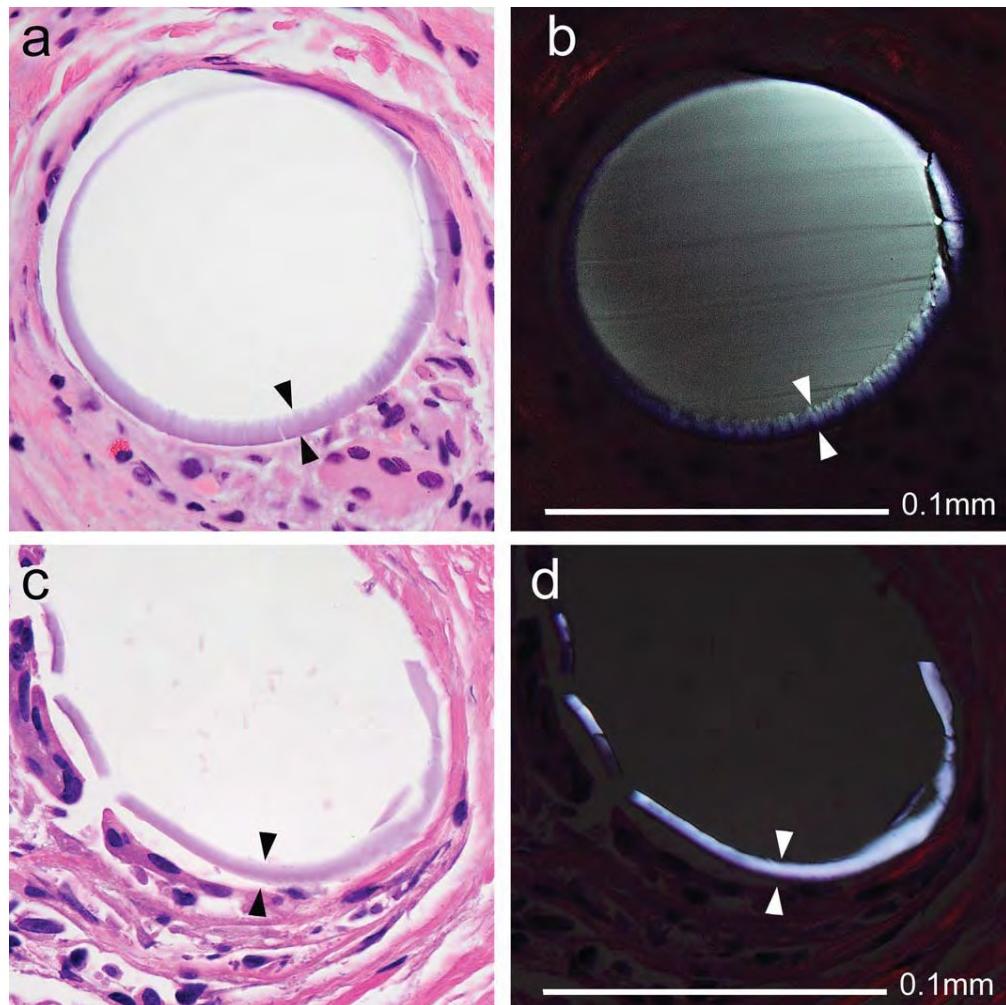
**FIGURE 2.** Histological sections, H&E stain,  $\times 100$  objective with oil immersion. The same cross section of a clear mesh fiber in regular (a) and polarized (b) light. The fiber has a layer of staining degraded polypropylene at the surface (between arrowheads). This layer has refractile properties of polypropylene in polarized light (b). In some areas the non-degraded core of the fibers detaches during histological processing while segments of the degraded layer stay attached to the tissue. Separated degradation layer in regular (c) and polarized (d) light. At sites like this, intensity of light passing through the degraded layer cannot be attributed to light scatter from the core. Note that tissue components including collagen have a much weaker birefringence than polypropylene (b and d). [Color figure can be viewed in the online issue, which is available at [wileyonlinelibrary.com](http://wileyonlinelibrary.com).]

Polypropylene. In polarized light, both the central core of the fibers and the outer layer showed similar refractile properties [Figure 2(b)]. The light intensity was uniform within the core while the outer layer had gradual reduction of the refractile ability toward the surface. Birefringence of the outer layer was also observed in the segments of the “bark” separated from the core [Figure 2(c,d)]. At these sites, the light brightness in the “bark” layer was due to its internal properties and could not be attributed to the scatter of light from the core. The adjacent tissue components containing collagen also showed birefringence, however of a much lower intensity. The tissue components also had a different structure and coloration.

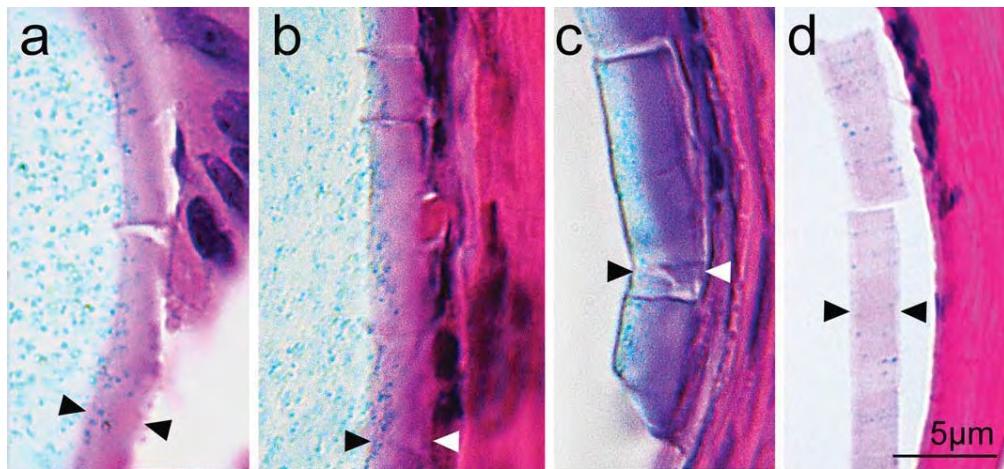
**FIGURE 3.** Degradation “bark” of the blue fibers manufactured with inclusion of blue dye granules, H&E stain,  $\times 100$  objective with oil immersion: (a) and (b) non-degraded core (left half of the images) and the degraded layer (between arrowheads). Note that the blue granules are retained in the layer of degraded polypropylene. Within the degraded “bark,” the granules degrade and loose color toward the surface. In (c) and (d) the non-degraded core detached from the slides similarly to Figure 2(c,d). At these sites, presence of the granules in the separated “bark” cannot be attributed to an overlap with the core. [Color figure can be viewed in the online issue, which is available at [wileyonlinelibrary.com](http://wileyonlinelibrary.com).]

into the material during its manufacture (Figure 3). The granules were seen in the non-degraded core of the fibers as well as to a variable degree in the outer degradation layer. In the latter, they were detected within the “bark” remaining on the core [Figure 3(a,b)] as well as in the segments of the “bark” separated from the core [Figure 3(c,d)]. The granules were mainly seen in the deeper layers of the “bark” and were not as frequent closer to the surface, which suggests that they also undergo degradation and lose color. The finding was a direct confirmation that the “bark” originated from the same material as the core of the fibers.

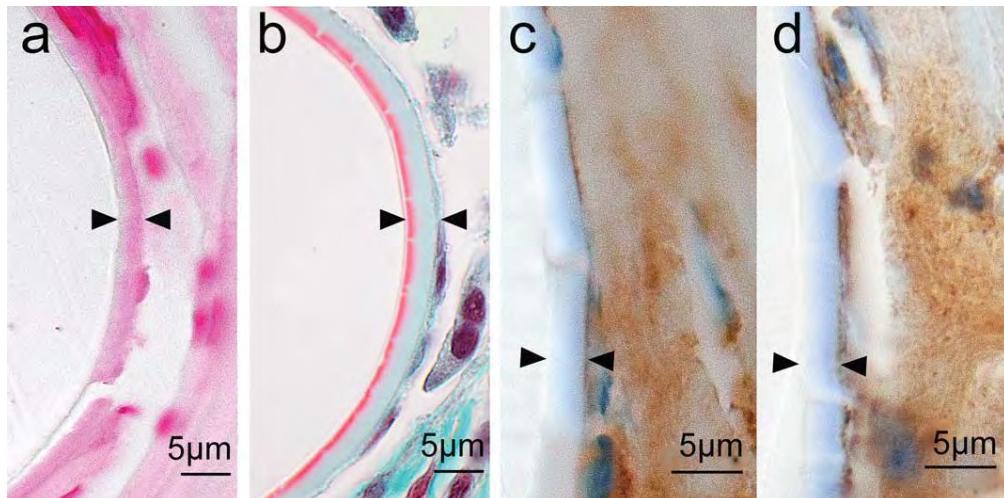
The brittleness, staining and birefringence characteristics of the “bark” were similar to those of calcium salts which are commonly deposited in degenerating tissues. Von Kossa stain was used for a sample set of 10 specimens to rule out presence of calcium salts in the outer “bark.” No calcium salts were detected in the brittle outer layer of the 10 specimens tested [Figure 4(a)].

**FIGURE 4.** Additional stains, all images taken with 100x oil immersion objective and cropped to a different magnification, polypropylene degradation layer is pointed between arrowheads: (a) Von Kossa stain is negative for calcium in the brittle “bark” (would stain calcium black), (b) trichrome stain shows that the deeper parts of the “bark” have smaller staining porosity (red) than those close to the surface (green) which correlates with TEM findings [Figure 6(b)], (c) immunohistochemical stain for immunoglobulin G (IgG, stained brown). IgG is present in almost all human tissues and fluids. It is deposited on the surface of degraded polypropylene but is not mixed within it. (d) Immunostain for the oxidizing enzyme of inflammatory cells myeloperoxidase (stains brown). [Color figure can be viewed in the online issue, which is available at [wileyonlinelibrary.com](http://wileyonlinelibrary.com).]

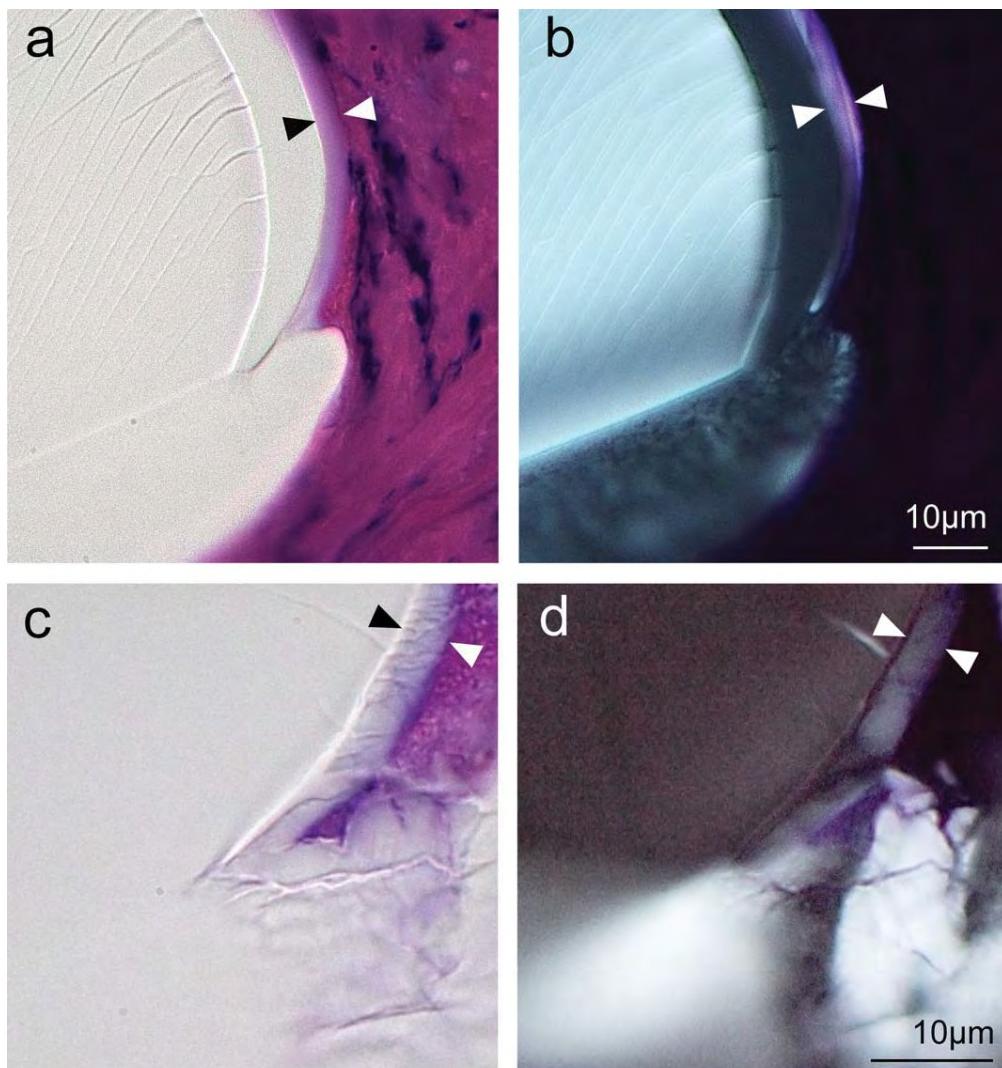
**FIGURE 5.** Melting of both non-degraded and degraded polypropylene caused by the surgical cautery, H&E,  $\times 100$  oil immersion: (a) and (b) the same site of fiber melting in regular and polarized light, (c) and (d) another site showing melding point. While molten the non-degraded core and the degradation “bark” formed a common pool of material. [Color figure can be viewed in the online issue, which is available at [wileyonlinelibrary.com](http://wileyonlinelibrary.com).]

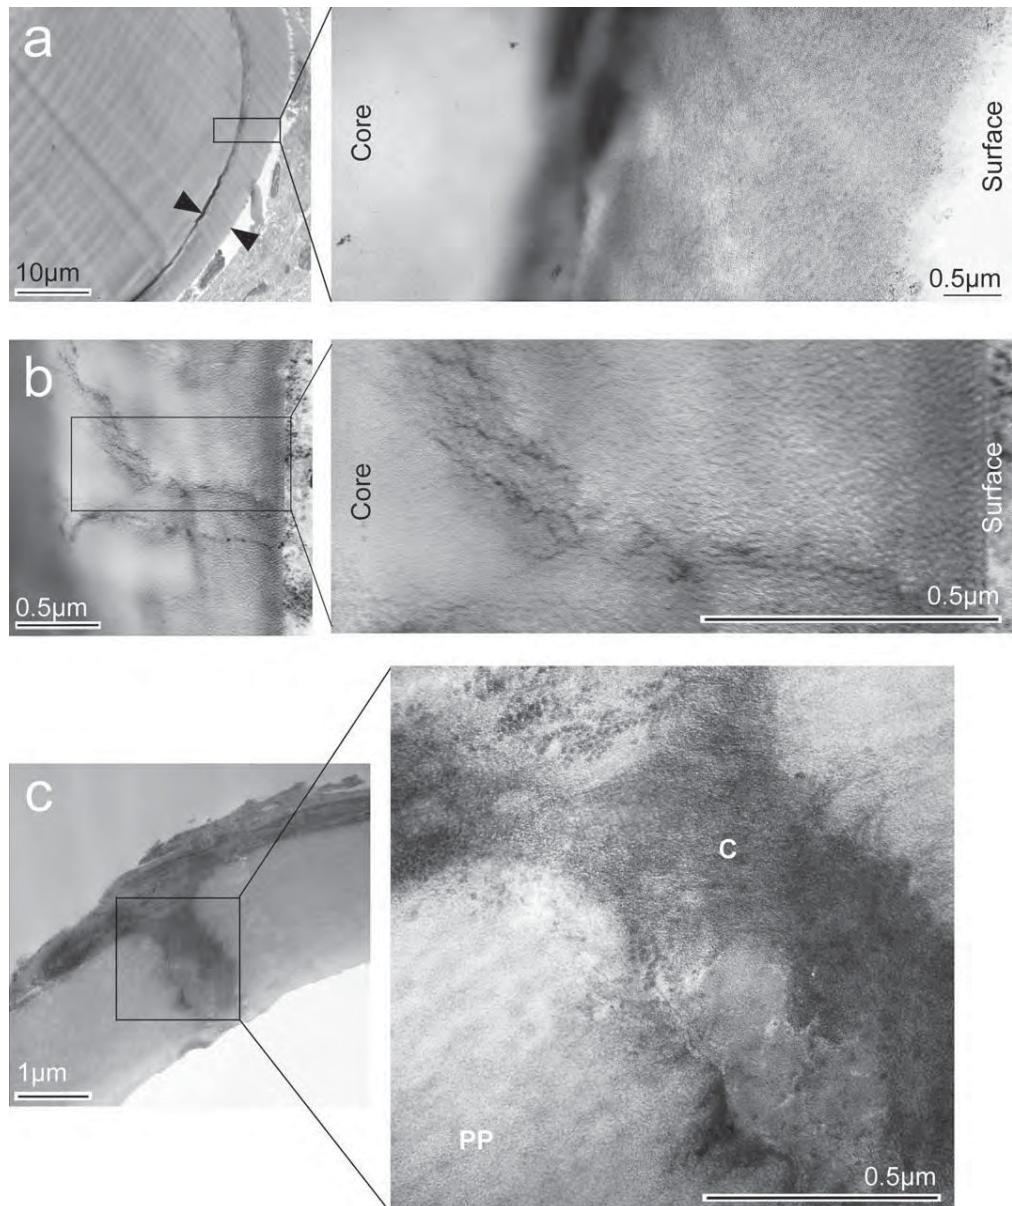
We used TEM to study the ultrastructural organisation of the degraded layer in cross sections. The mesh fibers showed an outer "bark" similar to that seen by light microscopy [Figure 6(a)]. There were no fibrillary (collagen, amyloid etc.) or other structures of connective tissue matrix within the "bark". Material composition of the outer layer and the core showed similar electron density; however, at high magnification the outer "bark" was noticeably more granular, especially toward the surface [Figure 6(a), insert].

The "bark" material had a lattice of fine branching cracks (nanocracks). This network of nanocracks was sparse closer to the core and expanded toward the surface [Figure 6(b)]. As seen in Figure 6(b) in addition to the nanocracks there were also occasional larger cracks occurring at random. These larger cracks seen by TEM corresponded to the cracks seen by light microscopy either on the surface (Figure 1) or in cross sections (Figure 2).

The "bark" either had a gradual transition into the core [Figure 6(b)] or showed a zone of circumferential fissuring partially separating it from the core [Figure 6(a)]. The mechanisms of "bark" separation from the core and formation of the larger cracks are likely linked since the cracks tended to turn at the interface between the "bark" and the core [Figure 6(b)]. The forces which produced the transverse (radial) cracks also acted as shear forces between the "bark" and the core.

An important finding was the detection of inflammatory cells partially migrated into and trapped within the fissures as shown in Figure 6(c). The shape of widened crevices and the depth of penetration indicated an active *in vivo* cellular migration. This phenomenon was observed at two separate sites.

**FIGURE 6.** Transmission electron microscopy. (a) Low power magnification of a cross-sectioned mesh fiber shows the degradation layer similarly to light microscopy, the insert shows an image composed of three high power fields to reconstruct the transition between the non-degraded core and the degradation “bark.” Note the fine nanocracks/nanopores in the degraded material. (b) Outer part of the fiber with gradual transition between the non-degraded core and the degraded polypropylene at the surface. The lattice of nanocracks expands toward the surface (left to right). There are also two larger cracks which start perpendicular to the surface but then turn at the interface between the core and the degraded layer. (c) A part of inflammatory cell (labeled C in insert) is trapped in a fissure within the degraded polypropylene (PP). Higher magnification (insert) shows cellular membrane at the cell-polypropylene interface (left wall of the fissure) and cellular organelles in the cell (chains of rounded structures, likely ribosomes).

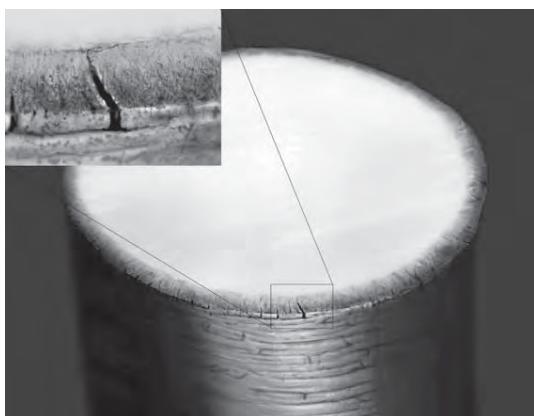
For better demonstration of the degradation "bark" we used light microscopic and TEM images to generate a 3-dimensional restoration of a mesh fiber (Figure 7).

**FIGURE 7.** A three-dimensional restoration of a cross sectioned mesh fiber.

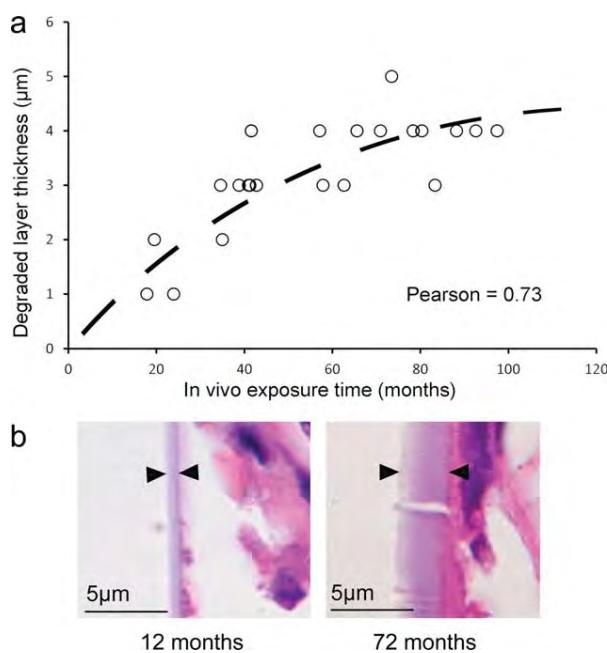
Out of all the specimens, 23 samples of explanted midurethral slings formed the largest group of meshes from the same manufacturer, of identical mesh type and with reliable records of implantation and excision dates. The range of *in vivo* interval (between implantation to excision) in the group was 18–97 months (mean 53). There was a good correlation (Pearson = 0.73) between the thickness of the degradation layer and the duration of *in vivo* exposure indicating that the thickness of degraded material grows while the mesh is in the body [Figure 8(a,b)]. There was a trend for a more rapid initial growth with gradual plateau subsequently.

**FIGURE 8.** Duration of *in vivo* exposure versus thickness of degraded layer in a group of explants of the same manufacturer and the same mesh design. (a) Thickness of the degradation "bark" increased over the years *in vivo* (Pearson correlation = 0.73). Note the trend of plateauing after 5–6 years. There was no correlation of the thickness with the duration of specimen storage in formalin (not shown, Pearson = -0.06). (b) Comparison of the "bark" in meshes explanted after 12 and 72 months in the body, H&E,  $\times 100$  objective with oil immersion, images cropped to the same magnification factor. [Color figure can be viewed in the online issue, which is available at wileyonlinelibrary.com.]
